## Crack Initiation Mechanism in Casting AC4B Aluminum Alloy Parts with Complex Structure

**Abstract:** Hot tearing is a common defect observed in aluminum (Al) components with intricate geometries. In this study, optical microscopy (OM), scanning electron microscopy (SEM), energy-dispersive X-ray spectroscopy (EDS), and the finite difference method (FDM) were employed to investigate the mechanisms underlying hot tearing in cast AC4B aluminum alloy engines. Shrinkage porosities, ranging from 300 to 500  $\mu\text{m}$  in size, were identified near the surface of the cast specimens. Additionally, numerous fractured brittle Fe-bearing phases were detected on the crack surfaces of the castings. Analysis of the secondary dendrite arm spacing (SDAS) across five typical locations revealed that the cooling rate at position 5 was significantly higher than at position 1. The improper solidification sequence between these positions disrupted the feeding of liquid metal to position 1 during solidification, potentially resulting in casting defects or crack formation. Numerical simulations further corroborated these findings, demonstrating that the solidification sequence influenced defect for

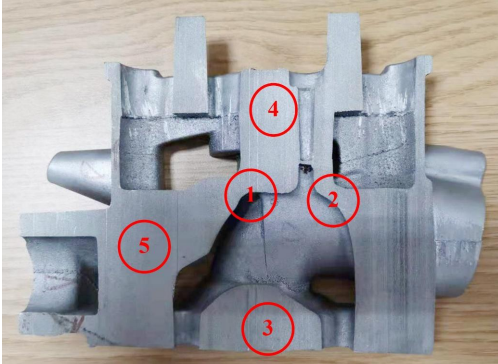
**Fig.1 Sketches of selected specimens for microstructure observation**

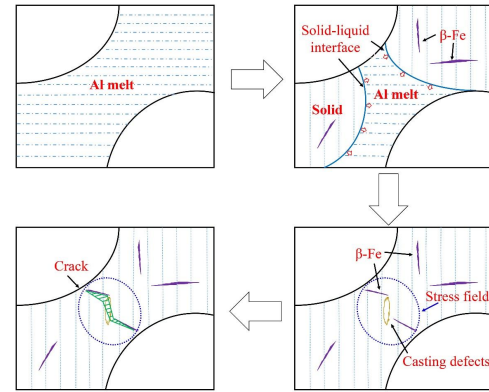
**Fig.2 Sketches of crack initiation during casting in position 1**

Fig.2 showed the sketches of crack initiation in position 1. During casting process, the solid-liquid interface converged at position 1. The improper solidification sequence impeded solidification feeding in position 1, and two interfaces' interaction could cause air entrainment. As the result, casting defects emerged in position 1. Since the solidification feeding was hindered, the solidification contraction induced stress field in this region. Plate-shaped  $\beta$ -Fe precipitated in Al alloy. In stress field, the elasticity and plasticity incompatibility between  $\beta$ -Fe and Al matrix lead to crack initiation in these region. The presence of casting defects facilitated crack coalescence with each other in the stress field. Therefore, cracks were frequently found in position 1.
